# RAND ESTATE NIAGARA- ON- THE- LAKE

EXISTING CONDITIONS AND SALVAGE PLAN  
LORD AND BURNHAM GLASSHOUSE

SCHOOL OF THE RESTORATION ARTS AT  
WILLOWBANK

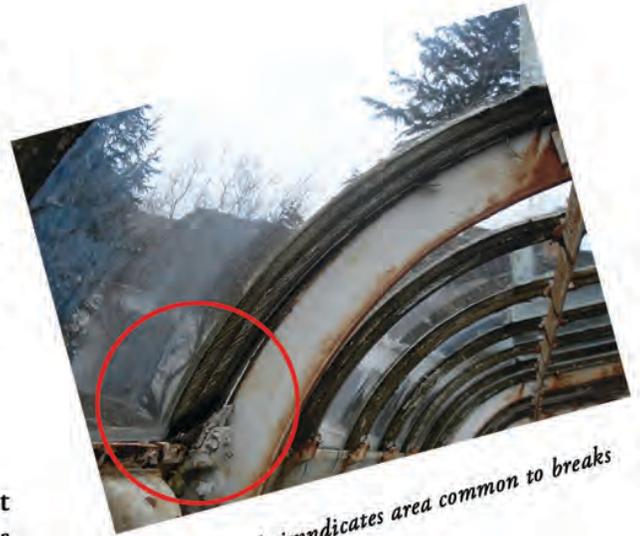
Most of the damage to the cypress wood has occurred in the areas of the curved eave, this is a result of the knee wall bulging outward and creating tension on the curve. The rafters, and rafter caps were painted with white aluminium paint, all other wooden elements were painted with white lead paint, to increase durability and for aesthetic reasons. A majority of the wood is in very good condition, but there is swelling due to exposure to the elements and most of the paint has peeled off

*Red Circle indicates area common to breaks*

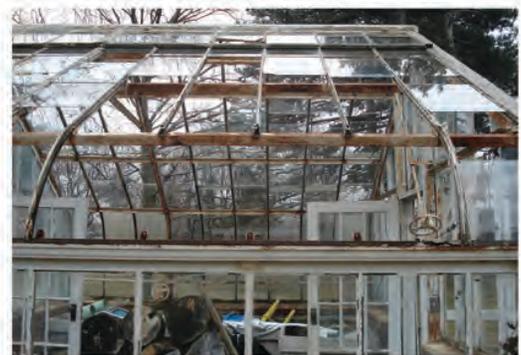
*South West corner - 3 missing curved wooden rafters*

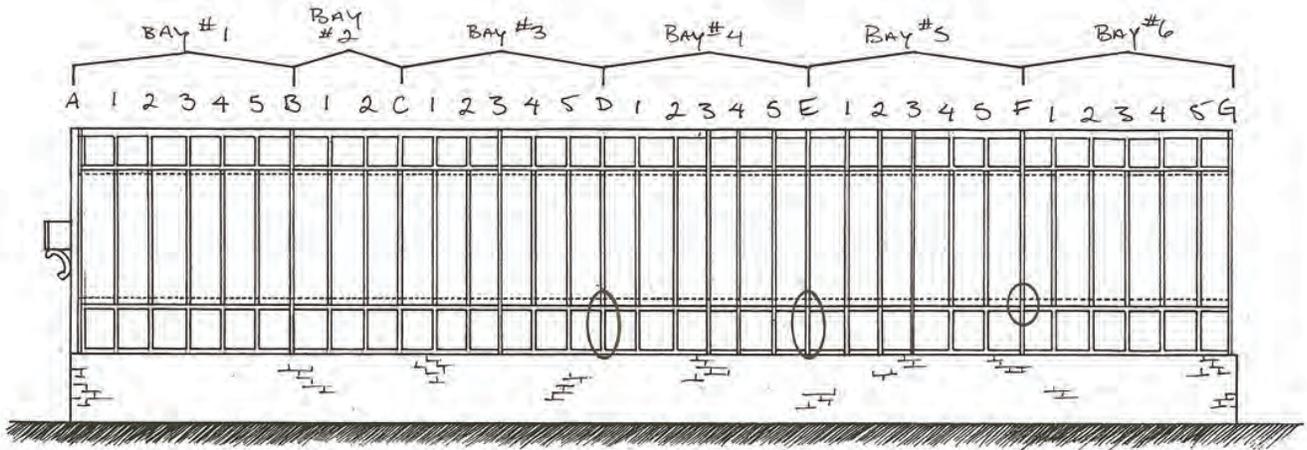
EAST ELEVATION

- Bay 1, rafter 2, 3 & 4: bottom curved portion of rafter unattached
- Bay 3, rafter 3 curved portion at sill cracked
- Sash wood rotted at bottom
- Rafter cap D cracked at bottom and top of curved portion
- Rafter cap E exterior decorative cap loose at bottom
- Bay 5, rafter 4 cracked a bottom of curved portion
- Rafter cap F exterior decorative cap missing
- Rafter cap G cracked at bottom of curved portion

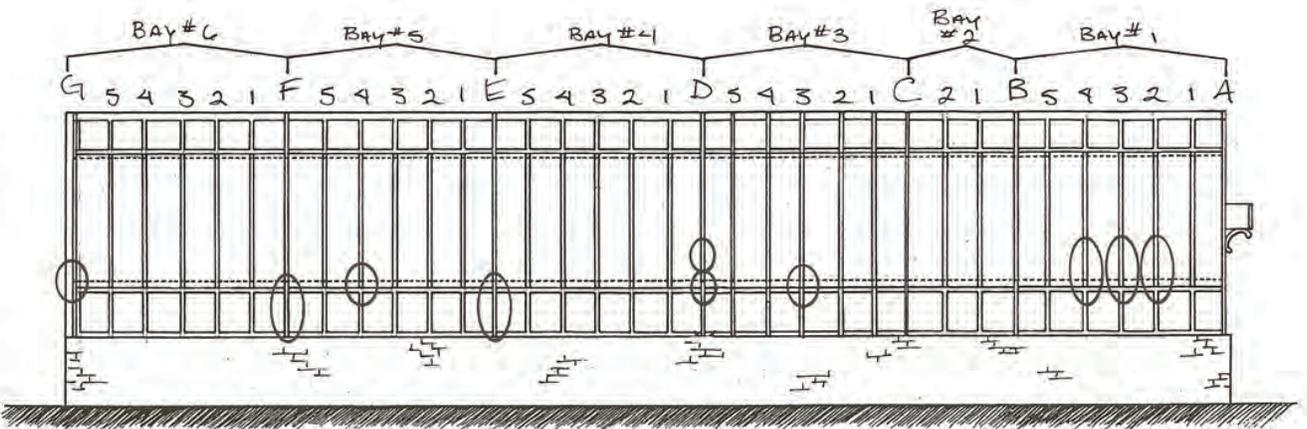
WEST ELEVATION

- Rafter cap D exterior decorative cap unattached
- Rafter cap E exterior decorative cap loose at bottom
- Rafter cap F cracked at bottom of curved portion

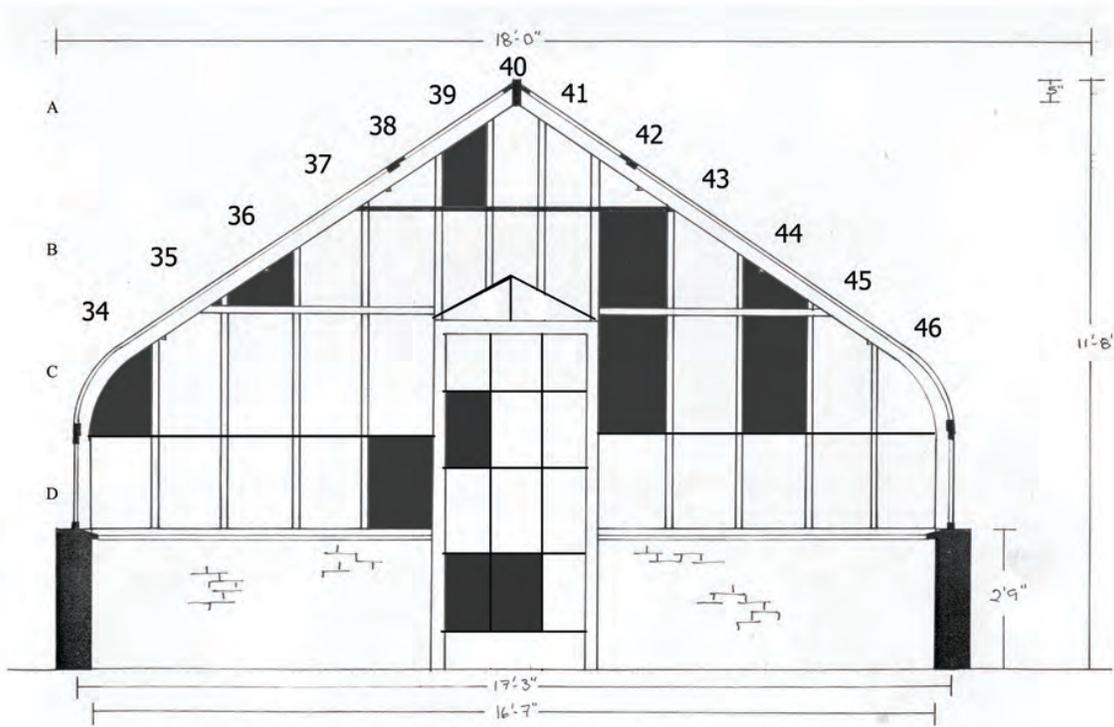
Damaged Glass
East Elevation	36
South Elevation and Partition	16
West Elevation	24
Total	66

\* Black squares show where glass is presently broken

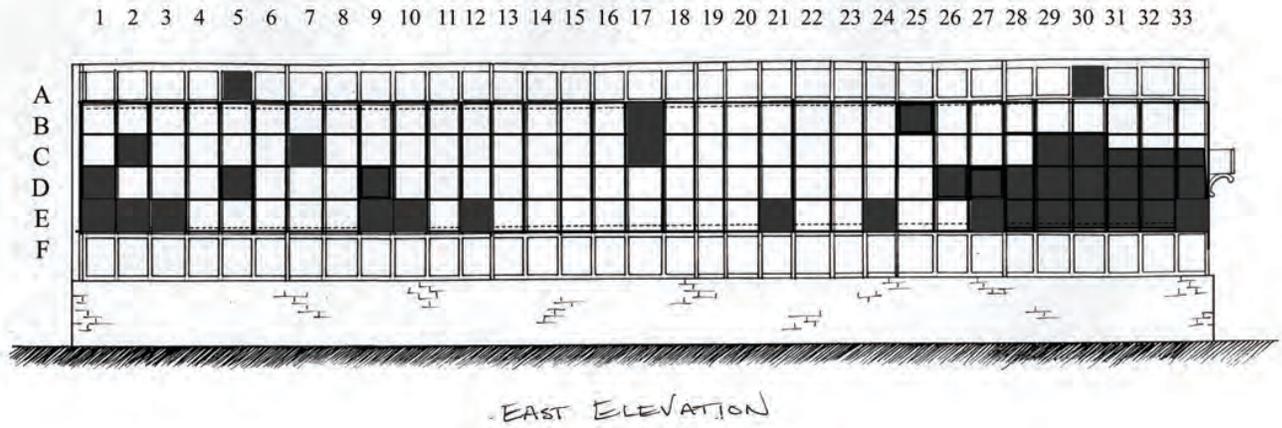
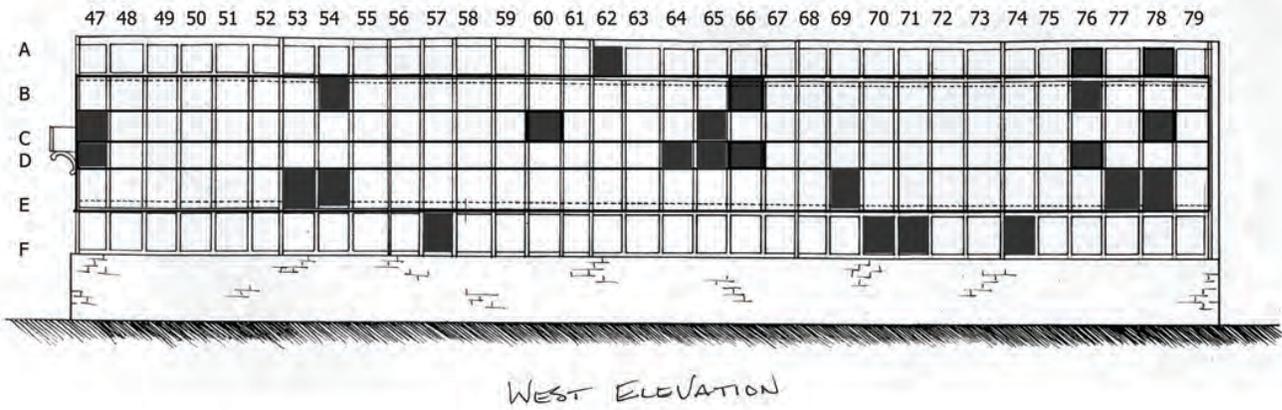
\* Black squares show where glass is presently broken

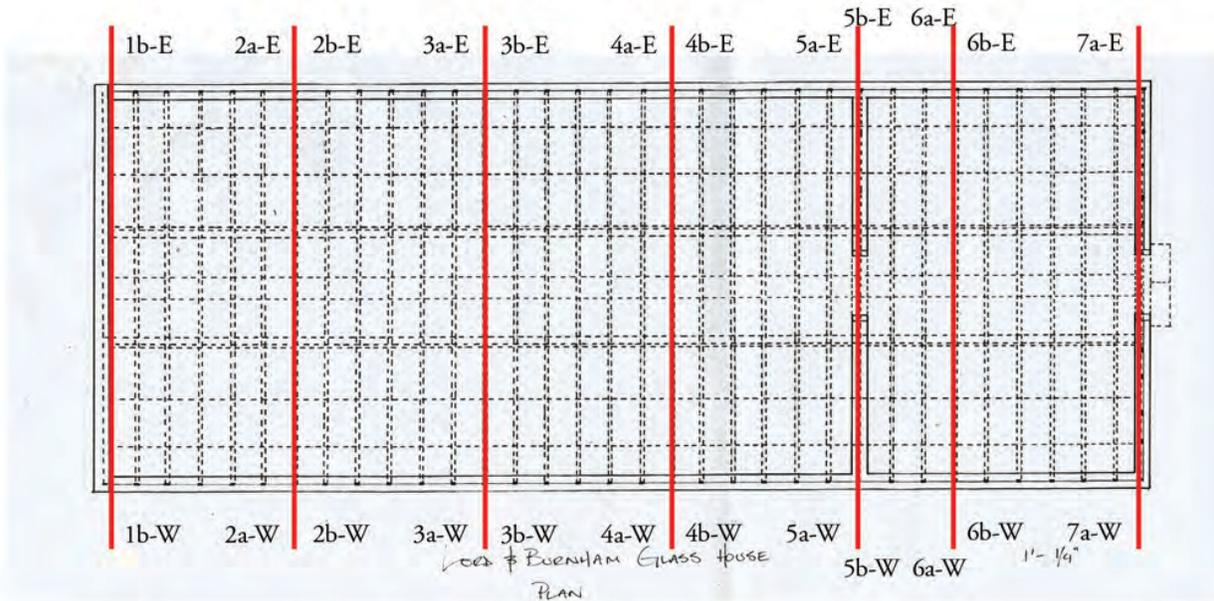
## Metal Rafter Plan of Sections Indicating Cracks

Large amounts of the cast iron element are still intact although due to the deterioration of the knee wall and separation of the brick courses the seven main metal rafter sections have become very unsafe and most of the Metal Eave fittings have broken at the cast sills and above the gutter. To better illustrate where these breaks have occurred the next 2 pages have labelled diagrams showing the exact locations of the breaks.

\* Please Note Section 7 is not shown on the next pages, there are no breaks

At one point all of the metal elements were coated in a white lead based paint, at this time due to neglect the majority of the paint has failed. This has caused the paint to peel and most of the metal has begun to rust. Great care must be taken when taking apart metal parts, as replacement parts are no longer in production and will be very expensive to have remade. Any broken pieces are to be kept; most parts may be welded back together.

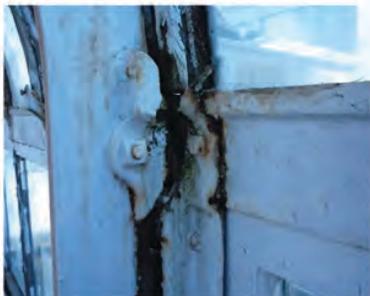
*Weldable crack at top joint*

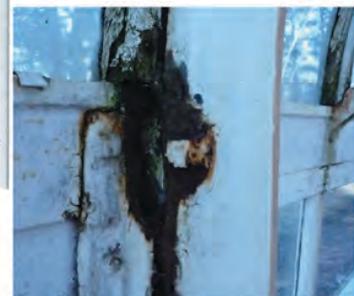
*Non weldable crack at top joint*

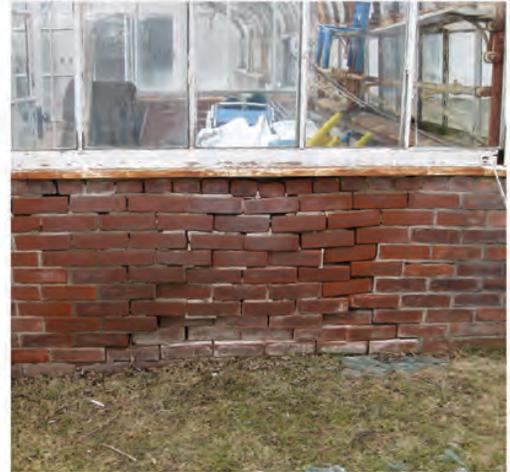
The condition of the brick supporting wall at the Lord Burnham glasshouse is of major concern. It appears to be the original foundation from the 1920's. The bricks are made of red clay and stamped Grimsby. The wall is laid out in a running bond configuration and is capped with a single header row. The brick courses have separated and no longer adequately supports the super structure above it. The brick will be left on site by the request of the property owner to further develop the landscape.

*Example buildings mortar condition - South Wall*

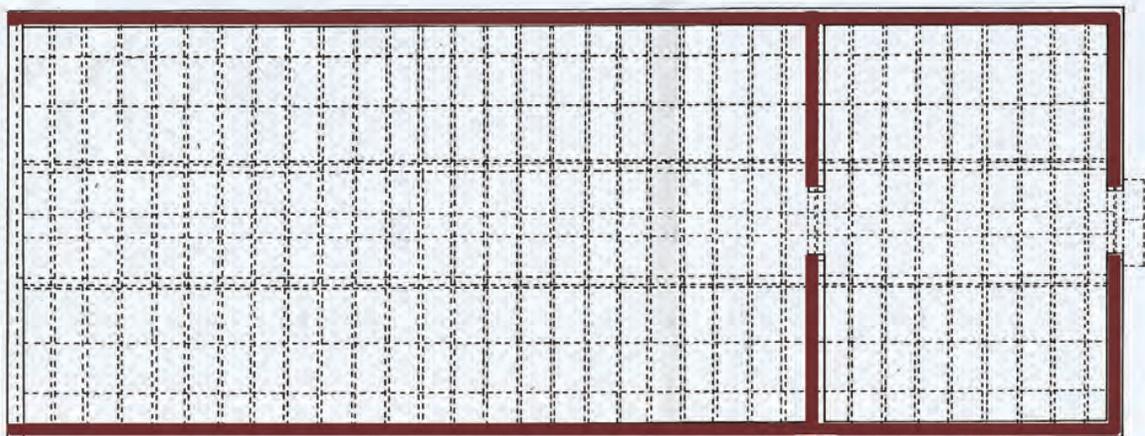
#### Brick Knee Wall Plan

To illustrate the overall condition of the brick elements the next two pages are labelled to show exactly where the deterioration and collapse of brick has occurred.

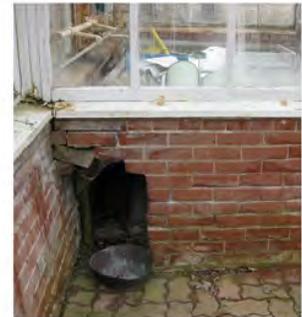
*Left Hole*

**\*\* The brick division wall has 2 holes roughly 22" high by 16" wide these hole were most likely used to connect the radiator pipes between rooms.**
