# RAND ESTATE NIAGARA- ON- THE- LAKE

EXISTING CONDITIONS AND SALVAGE PLAN  
LORD AND BURNHAM GLASSHOUSE

SCHOOL OF THE RESTORATION ARTS AT  
WILLOWBANK

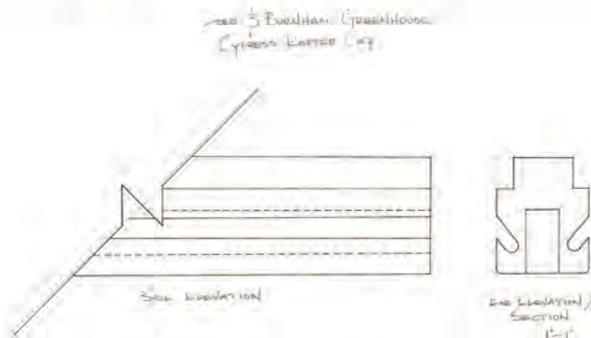
*Rafter Cap - Elevation and Section*

- Bay 1, rafter 2, 3 & 4: bottom curved portion of rafter unattached
- Bay 3, rafter 3 curved portion at sill cracked
- Sash wood rotted at bottom
- Rafter cap D cracked at bottom and top of curved portion
- Rafter cap E exterior decorative cap loose at bottom
- Bay 5, rafter 4 cracked a bottom of curved portion
- Rafter cap F exterior decorative cap missing
- Rafter cap G cracked at bottom of curved portion

- Rafter cap D exterior decorative cap unattached
- Rafter cap E exterior decorative cap loose at bottom
- Rafter cap F cracked at bottom of curved portion

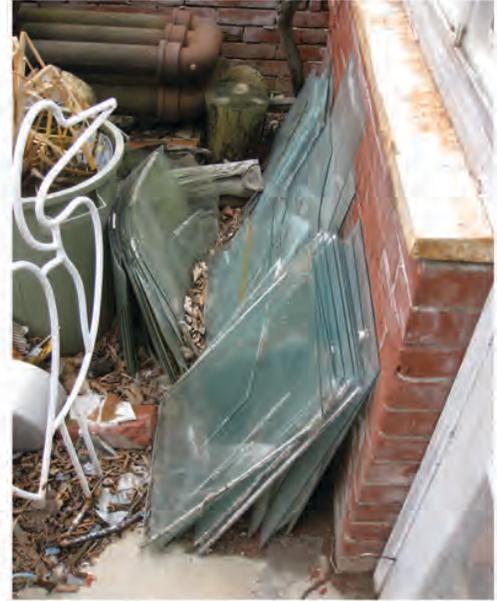
### Glass Total Chart

The glass is a combination of original rolled plate glass, newer flat glass and Plexiglas panels. Due to weathering and lack of maintenance and the shifting of the building some pieces have completely fallen out. Of those still in place, many have slipped down from their original position and now overlap the panes below them. The glass panes are held in place by a layer of putty on both sides with zinc nails along the bottom edges. Much of the putty has failed and has separated from the wood Rafters causing the panes to slip down. Some panes have stayed in place with the original overlap of 3/8ths of an inch but most have slipped out of place and dirt has penetrated between the panes. In general the glass is very unstable and there is broken glass lying on the ground from panes that have fallen off. Inside the greenhouse there are several unbroken panes that have been removed and stacked against the wall.

Damaged Glass
East Elevation	36
South Elevation and Partition	16
West Elevation	24
Total	66

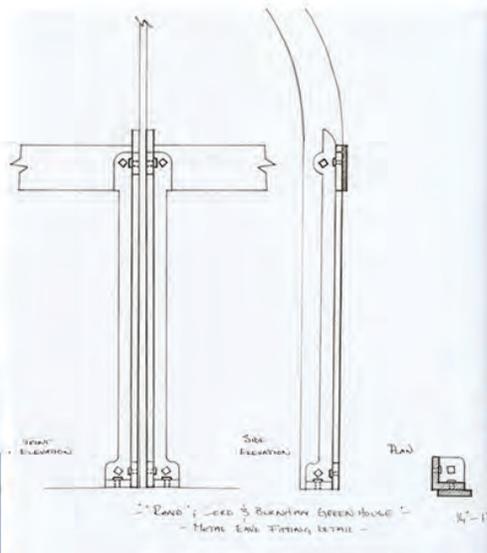
*Drawing of indicated cranked part*

Large amounts of the cast iron element are still intact although due to the deterioration of the knee wall and separation of the brick courses the seven main metal rafter sections have become very unsafe and most of the Metal Eave fittings have broken at the cast sills and above the gutter. To better illustrate where these breaks have occurred the next 2 pages have labelled diagrams showing the exact locations of the breaks.

At one point all of the metal elements were coated in a white lead based paint, at this time due to neglect the majority of the paint has failed. This has caused the paint to peel and most of the metal has begun to rust. Great care must be taken when taking apart metal parts, as replacement parts are no longer in production and will be very expensive to have remade. Any broken pieces are to be kept; most parts may be welded back together.

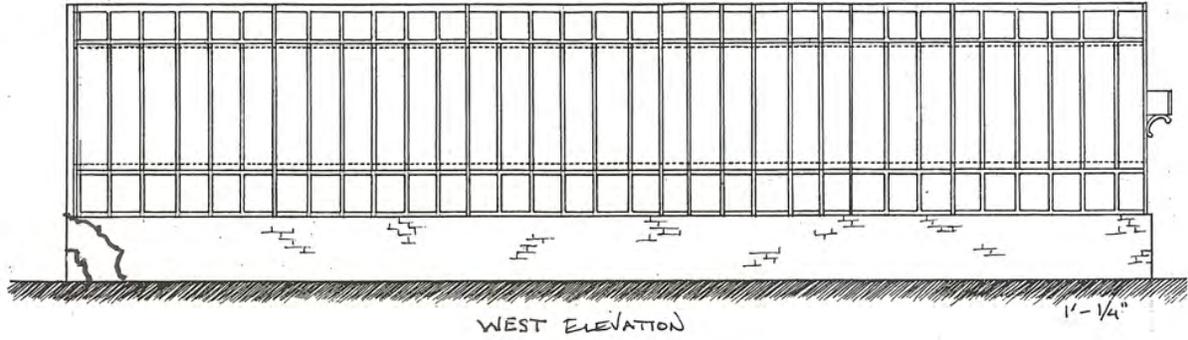
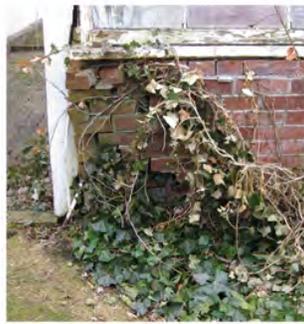
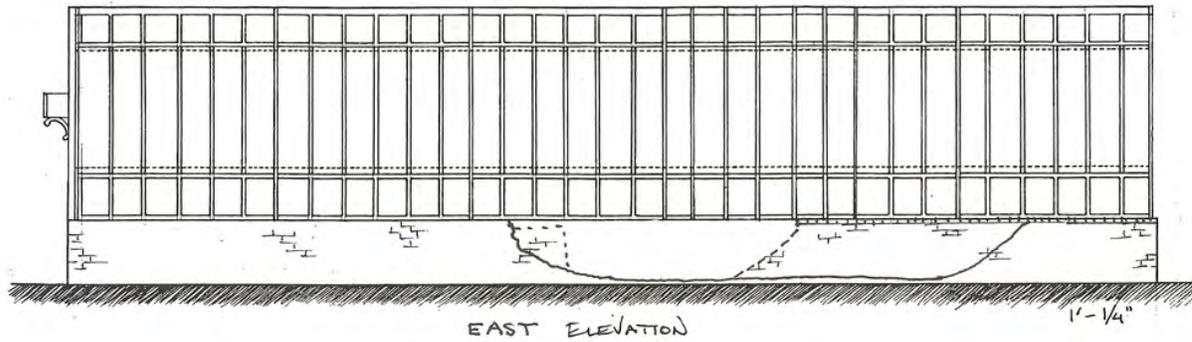
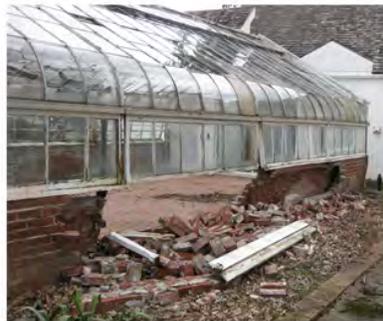
The condition of the brick supporting wall at the Lord Burnham glasshouse is of major concern. It appears to be the original foundation from the 1920's. The bricks are made of red clay and stamped Grimsby. The wall is laid out in a running bond configuration and is capped with a single header row. The brick courses have separated and no longer adequately supports the super structure above it. The brick will be left on site by the request of the property owner to further develop the landscape.

To illustrate the overall condition of the brick elements the next two pages are labelled to show exactly where the deterioration and collapse of brick has occurred.
